Date **11/17/2021**
Customer **Beth Piorecky**
Repair Order **211117007**

Vehicle **2018 Toyota Sienna**
License Plate **BC KJ713E**
Odometer **44,998 km**
VIN **5TDDZ3DCXJS209337**

Digital Midas Touch Vehicle Inspection

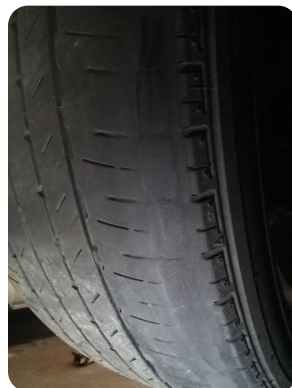
Inspection Point		Finding/Recommendations	
Right Front Tire Condition	4 /32nds	✗	<p>Inner shoulder wear, casing showing</p> <p>Finding: Tire is below 5/32's wear YELLOW</p> <p>Recommendation: Budget for tire replacement soon</p>

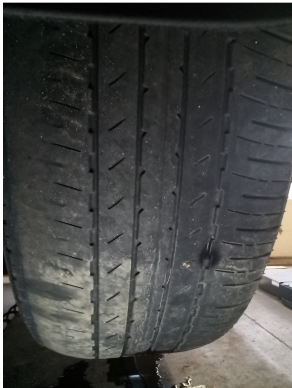
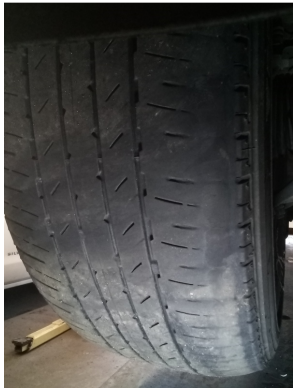
Shocks and Struts		✓	
Exhaust System		✓	
Brake symptoms observed		✓	All pads 5-6 mm
Driveline		✓	
Spark Plugs		✓	
Timing Belt		✓	
Fluid Leaks	Yes	✓	
Midas Courtesy Check 3		Finding/Recommendations	
Left Front Tire Pressure	36 psi	✓	
Left Rear Tire Pressure	36 psi	✓	
Right Rear Tire Pressure	36 psi	✓	
Right Front Tire Pressure	36 psi	✓	
Wheel alignment ok?	No	✗	Front tires showing inner shoulder wear.
